Transport
Canada

TP 185E
Issue 3/2013

AVIATION SAFETY LETTER

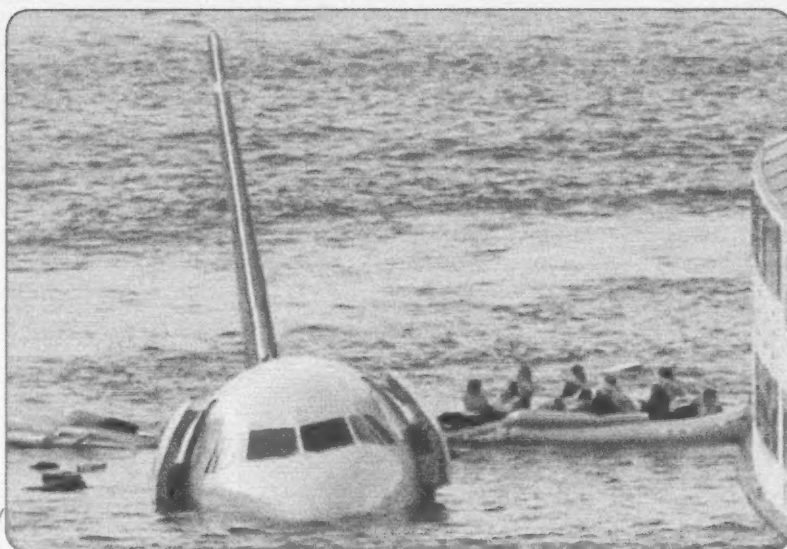
The off-wing ramp/slides on the accident airplane, as is typical in the industry, had no quick-release girts to enable occupants to free the ramp/slides from the sinking airplane for flotation out of the water or for use as handholds.

"Some passengers immediately recognized their usefulness and boarded the ramp/slides to get out of the water," the report said. "Eventually, about eight passengers succeeded in boarding the left off-wing slide and about 21 passengers, including the lap-held child, succeeded in boarding the right off-wing ramp/slide."

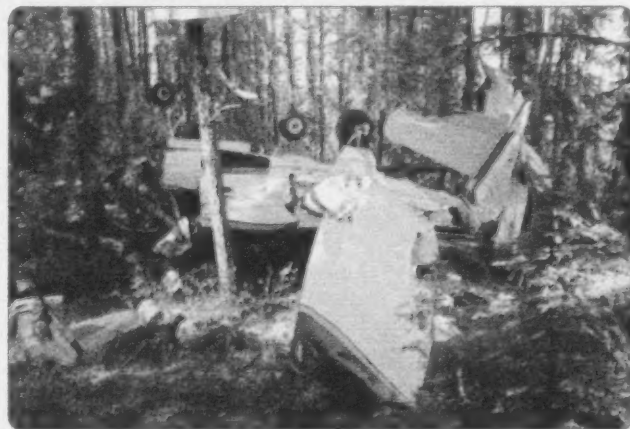
TSB Final Report A10C0060—Fuel Starvation and Forced Landing

On May 13, 2010, a Beech 95-55 departed Thicket Portage for a day VFR flight to Thompson, Man., about 29 NM north. Shortly after takeoff, the pilot used his cell phone to contact the Winnipeg flight information centre (FIC). The pilot indicated that the aircraft was experiencing an electrical problem and that the flight would arrive at Thompson in 12 min, without radios or transponder. There were no further communications with the aircraft. About 30 min after the telephone call was received, a series of emergency signals from a tracking system carried by the pilot were received. A helicopter was dispatched to the location indicated by the tracking system. The aircraft was located about 3 NM east of Pikwitonei, about 25 NM northeast of Thicket Portage and 27 NM southeast of Thompson. The pilot, the sole occupant, sustained minor injuries. The aircraft was destroyed on impact with trees and terrain, but the emergency locator transmitter (ELT) did not activate. There was no post-crash fire. The accident occurred during daylight hours at about 09:50 CDT. The TSB authorized the release of this report on February 16, 2011.

The first indication of a loss of electrical power occurred immediately after takeoff, when the electrically-operated landing gear did not fully retract and all avionics power was lost. The transponder also stopped transmitting and the aircraft was no longer being tracked by radar.

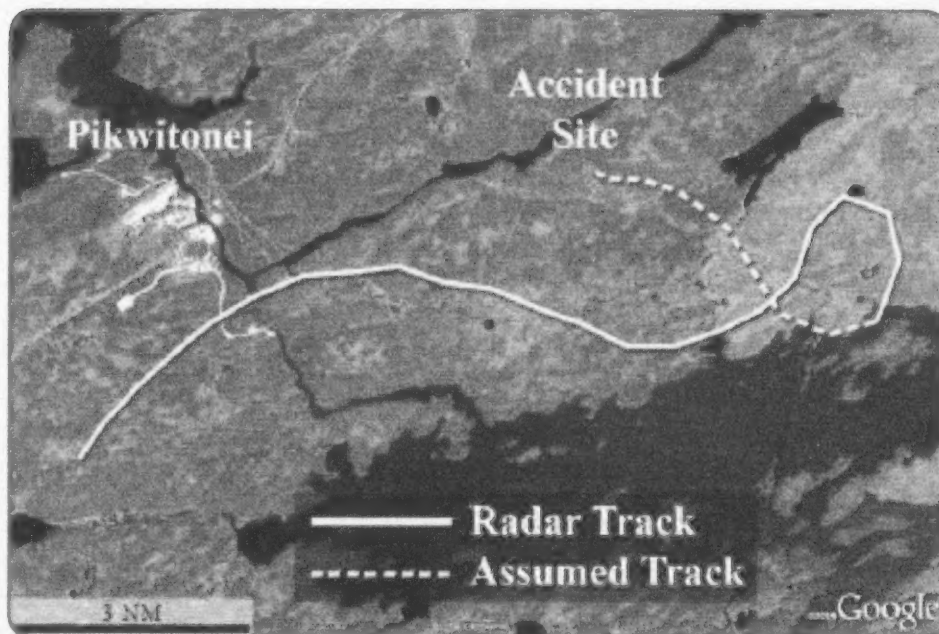
The engines stopped shortly after the aircraft was rocked to lock the landing gear. The loss of fuel supply and the stoppage of the right engine were likely due to fuel exhaustion as the fuel in the right main tank became depleted. The left engine stopped almost immediately after the right engine had stopped. The stoppage of the left engine may also have

resulted from fuel exhaustion if the engines had burned an equal amount of fuel since the aircraft had last been fueled. It is more likely, however, that the engine stopped as a result of fuel starvation as the low level of fuel in the tank allowed the port to become uncovered when the aircraft experienced yaw from asymmetric thrust. The decision not to feather the propeller on the right engine would have resulted in increased drag and greater yaw forces, causing the fuel to move away from the fuel port at the inboard edge of the left tank. With the gear already down, the pilot's decision not to feather either propeller increased the rate of descent and reduced the pilot's ability to control the forced landing.

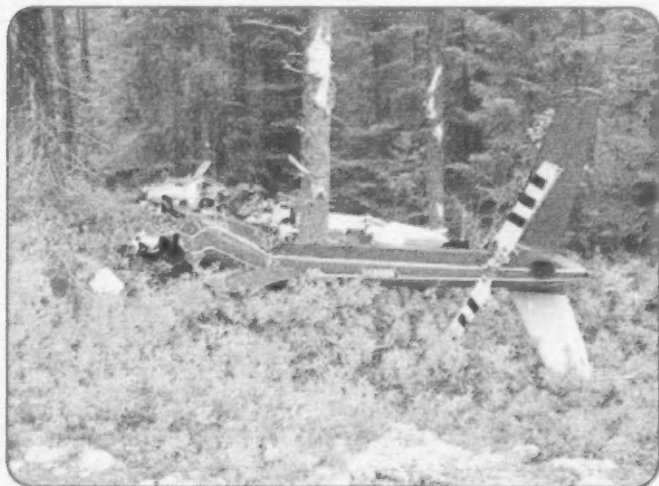
On July 23, 2010, at 12:26 EDT, a commercially registered Bell 206B departed North Bay for a VFR flight to Kapuskasing, Ont. The pilot was repositioning the helicopter for sightseeing flights planned at a local festival the next day. Another company pilot was a passenger. During the flight, poor weather conditions were encountered and approximately 1 hr and 12 min after departure, in the vicinity of Elk Lake, the helicopter collided with a tower approximately 79 ft in height. The helicopter then struck the ground approximately 430 ft beyond the tower and was destroyed. Both occupants were fatally injured; there was no post-impact fire. The emergency locator transmitter (ELT)

functioned, but its range was reduced significantly as its antenna was sheared on impact. *The TSB authorized the release of this report on November 16, 2011.*

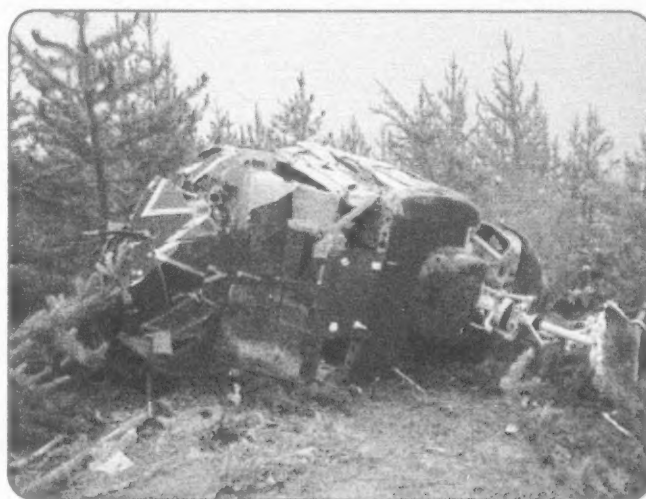
On July 29, 2010, a Bell 214B-1 helicopter with two pilots on board, was engaged in firefighting operations approximately 20 NM northwest of Lillooet, B. C. At 11:24 PDT, after refilling the water bucket, the helicopter was on approach to its target near a creek valley. As the helicopter slowed

and started to descend past a ridgeline into the creek valley, the engine lost power. The pilot-in-command, seated in the left-hand seat, immediately turned the helicopter left to climb back over the ridgeline to get to a clearing, released the water bucket and the 130-foot long-line from the belly hook, and descended toward an open area to land. The helicopter touched down hard on uneven, sloping terrain and pitched over the nose. When the advancing main rotor blade contacted the ground, the airframe was in a near-vertical, nose-down attitude, which then rotated the fuselage, causing it to land on the left side. A small post-crash fire ignited. The pilot-in-command sustained a concussion and was rendered unconscious. The co-pilot escaped with minor injuries and dragged the pilot-in-command from the wreckage. The pilot-in-command regained consciousness a few minutes later. The helicopter was substantially damaged. The 406 MHz emergency locator transmitter (ELT) activated, but its antenna fitting was fractured; as a result, the search and rescue satellite network did not receive a signal. *The TSB authorized the release of this report on April 17, 2013.*

The occurrence helicopter experienced a loss of power at a critical phase of flight while the pilot was preparing to drop a load of water. In response to the power loss, the pilots identified a nearby landing area and carried out an emergency landing. However, the nature and slope of the terrain in the touchdown area caused the helicopter to roll over after touchdown. The combination of low airspeed, high-density altitude (approximately 9 000 ft), height above ground at the time of the power loss, gross weight of the helicopter, and nature and slope of the terrain precluded an uneventful landing.

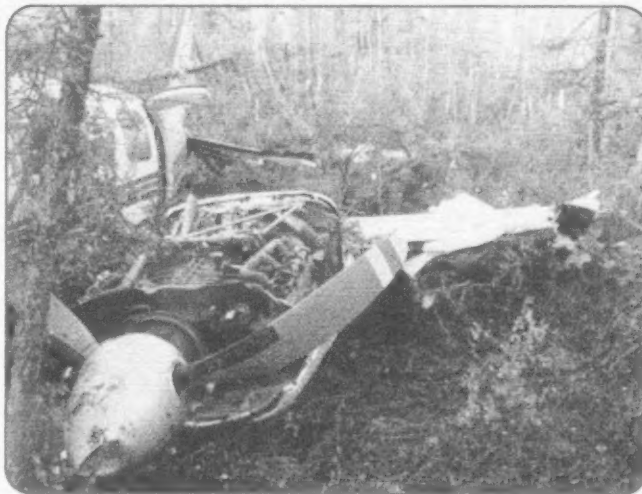
TSB Final Report A10C0159—Engine Shut-down and Forced Landing

On September 10, 2010, a privately registered Piper PA 31-310 Navajo was on a VFR flight from Pickle Lake to Kashechewan, Ont., with a pilot and three passengers on board. Shortly after reaching cruise altitude, there was a brief rumble from the left engine, accompanied by decreases in exhaust and cylinder head temperatures. Consequently, the pilot reversed course. While en route to Pickle Lake, left engine performance deteriorated and the pilot shut the engine down. Unable to maintain altitude, the pilot made a forced landing about 30 NM east of Pickle Lake at 12:15 CDT. The pilot and one passenger sustained minor injuries. The aircraft sustained substantial damage, but there was no post-crash fire. The emergency locator transmitter (ELT) activated on impact. *The TSB authorized the release of this report on July 4, 2011.*

The initiating event of the occurrence was a magneto failure in the left engine. This failure was the result of the loss of retention of the bushing in the distributor block of the left magneto. The subsequent misalignment of the distributor rotor caused the rotor to fall out of synchronization with the engine. This caused the left engine to run rough, backfire and lose power. The clean, shot-blasted appearance of the piston crowns indicates that the rough running and back firing likely released combustion products that contaminated spark plugs of both magneto systems. It could not be determined whether the engine would have been capable of producing significant power running on the right magneto alone.

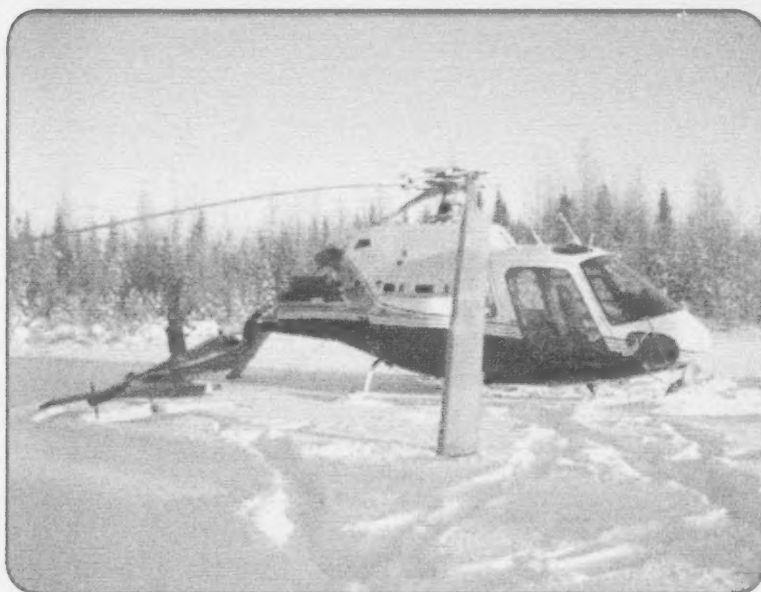
TSB Final Report A10C0214—Engine Power Loss and Autorotative Landing

On December 12, 2010, during daylight hours, a Eurocopter AS 350 B2 helicopter was conducting slinging operations approximately 6 NM northeast of Pickle Lake Airport, Ont. The pilot had picked up a load of fuel barrels with a longline and was transitioning into forward flight. At low airspeed, and approximately 250 ft AGL, the helicopter's engine lost power. The pilot jettisoned the load and attempted an autorotative landing. The helicopter struck the ground in a level attitude, and one of the main rotor blades severed the helicopter's tail boom. The pilot was not injured and was able to exit the aircraft without assistance. The helicopter was substantially damaged. There was no post-crash fire and the emergency locator transmitter (ELT) did not activate. The accident occurred at 08:00 CST. *The TSB authorized the release of this report on January 3, 2012.*

Testing of the engine and its fuel system could not identify a mechanical reason for the engine power loss. A blockage in the air inlet or fuel delivery system could cause an engine to flame out, but no such blockage or contamination was noted. Testing of the fuel system showed that air can become entrapped in the fuel system which could not be bled out by normal maintenance action prior to flight. The analysis will therefore examine the role that air entrapment may have played in this occurrence.

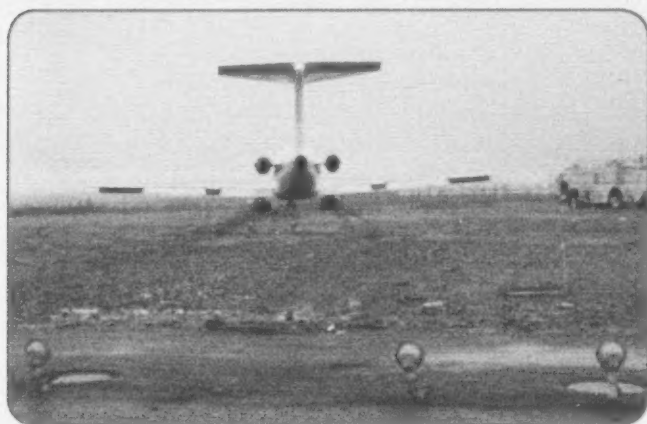
TSB Final Report A11A0035—Runway Overrun

On July 16, 2011, at 06:45 NDT, a Boeing 727-281 departed Moncton International Airport, N.B., for St. John's International Airport, N.L., on a scheduled cargo flight with three crew members on board. An instrument landing system (ILS) approach was carried out and at 08:09 NDT the aircraft touched down on Runway 11. Following touchdown, the crew was unable to stop the aircraft before the end of the runway. The aircraft came to rest in the grass, with the nose wheel approximately 350 ft beyond the end of the pavement. There were no injuries and the aircraft had minor damage. *The TSB authorized the release of this report on January 23, 2013.*

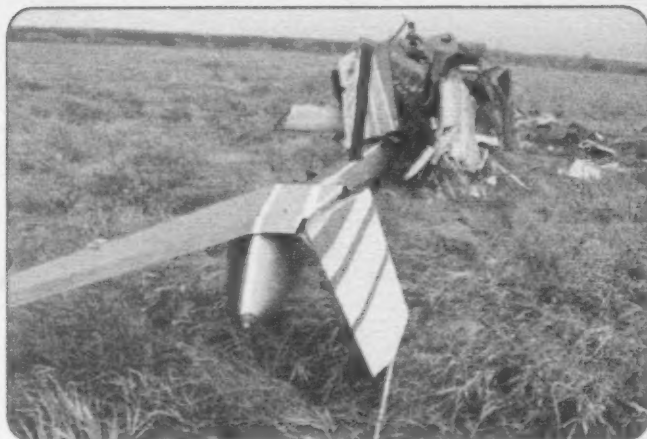
TSB Final Report A11W0152—Continued Visual Flight into Instrument Meteorological Conditions—Collision with Terrain

On October 5, 2011, a Bell 206B helicopter was on a VFR flight from Whitecourt, Alta., to Drayton Valley Industrial Airport, Alta. The flight encountered and continued into instrument meteorological conditions (IMC). The aircraft collided with terrain approximately 1 NM south of Drayton Valley Industrial Airport, at 18:20 MDT, during daylight hours. There was no post-crash fire. The pilot, who was the sole occupant, was fatally injured. No emergency locator transmitter (ELT) signal was received by search and rescue authorities. *The TSB authorized the release of this report on October 31, 2012.*

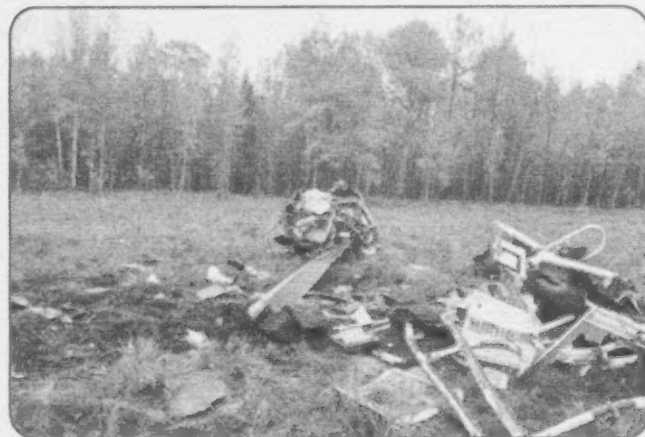
The pilot was in the habit of not wearing the available shoulder harnesses. These harnesses serve to maintain occupants in an upright position in order to take full advantage of all the crashworthiness features of the aircraft. To what extent this may have contributed to the injuries sustained could not be determined. The fact that the pilot was not wearing a helmet likely would not have been a factor in survivability due to the severity of impact forces.
